APPENDIX I

Photographs

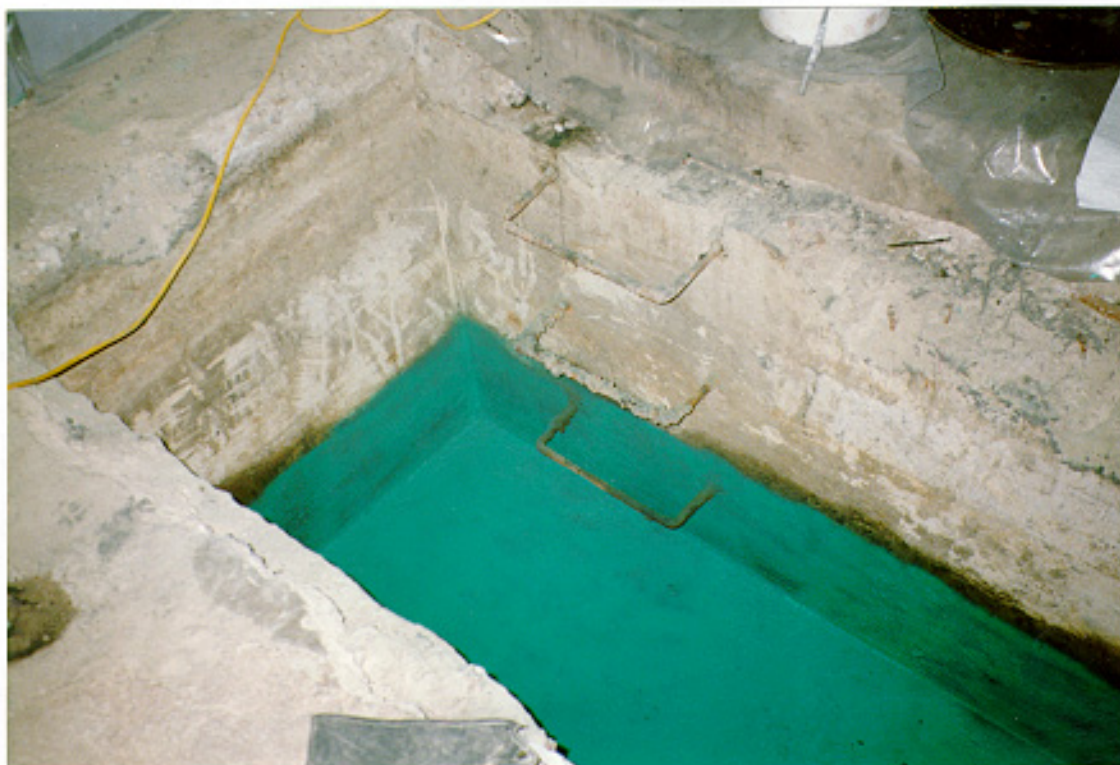
LARGE HALLWAY

The cylinder test pit in the large hallway was lined with concrete and contained 2 to 3 feet of black grease or sludge. The pit was remediated to below criteria for all analytes.

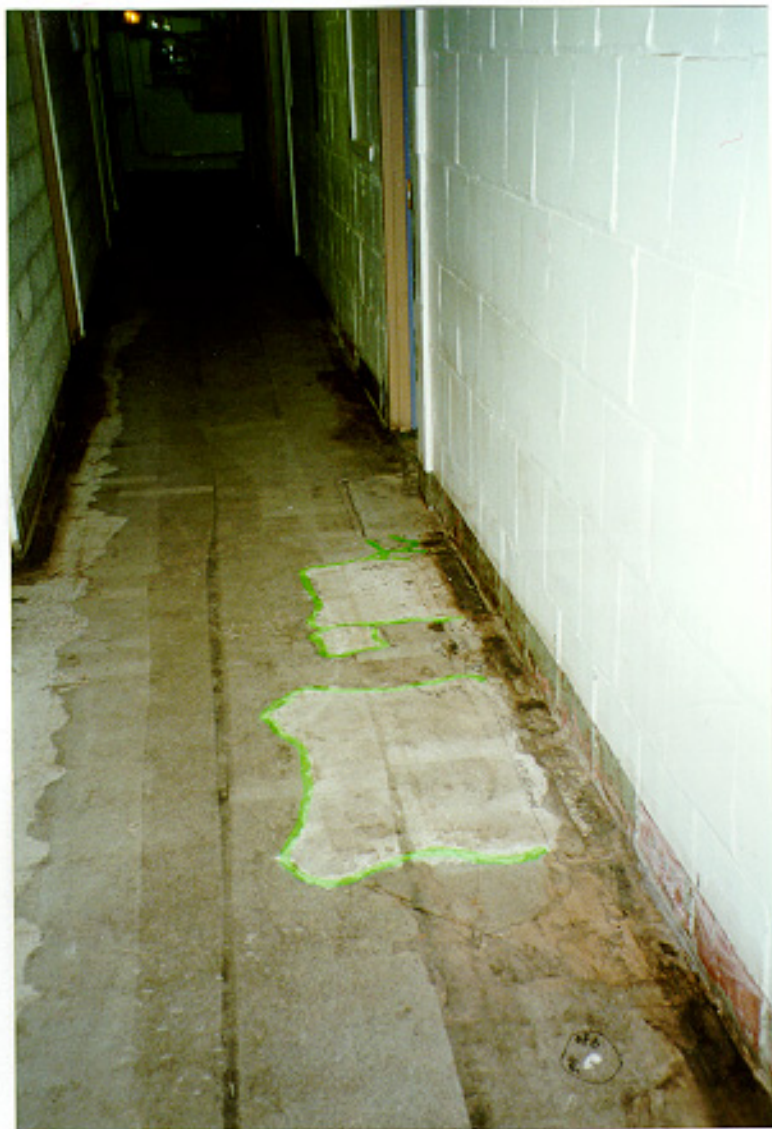
SMALL HALLWAY

The floor tiles were removed to permit surveying of the concrete floor. Contamination was found primarily near the office doorways.

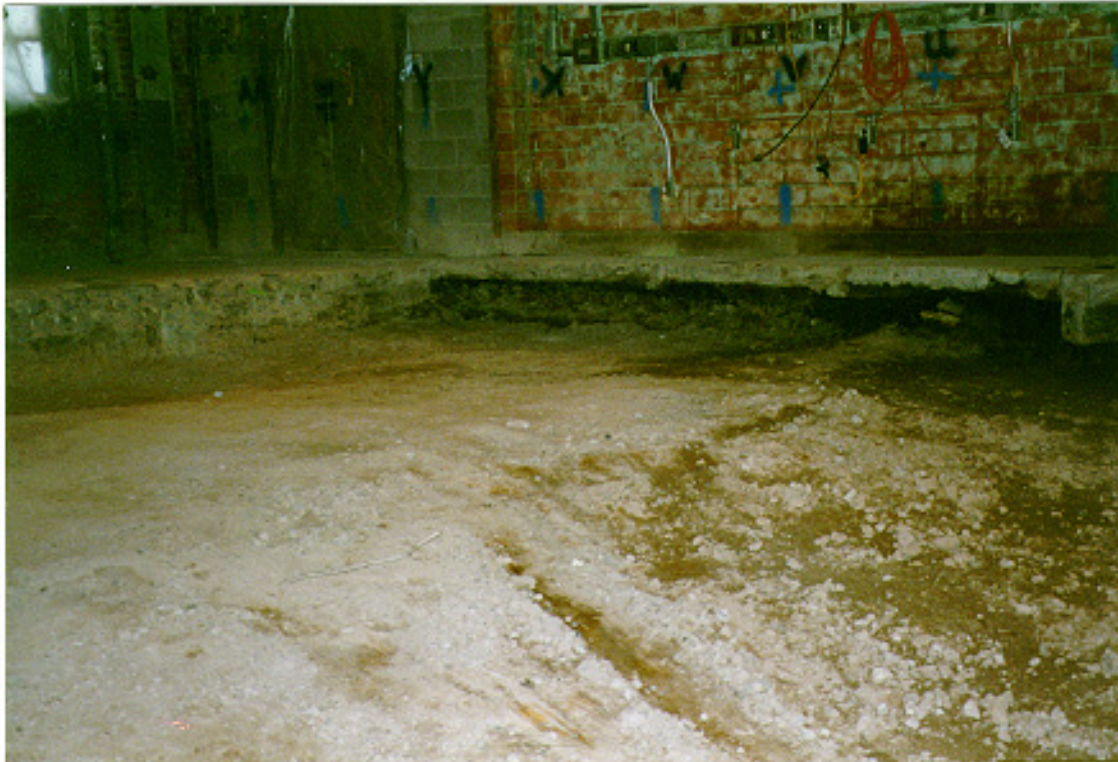
AREAS 12 AND 13

A layer of black ash was found underneath most of the slab in Areas 12 and 13.

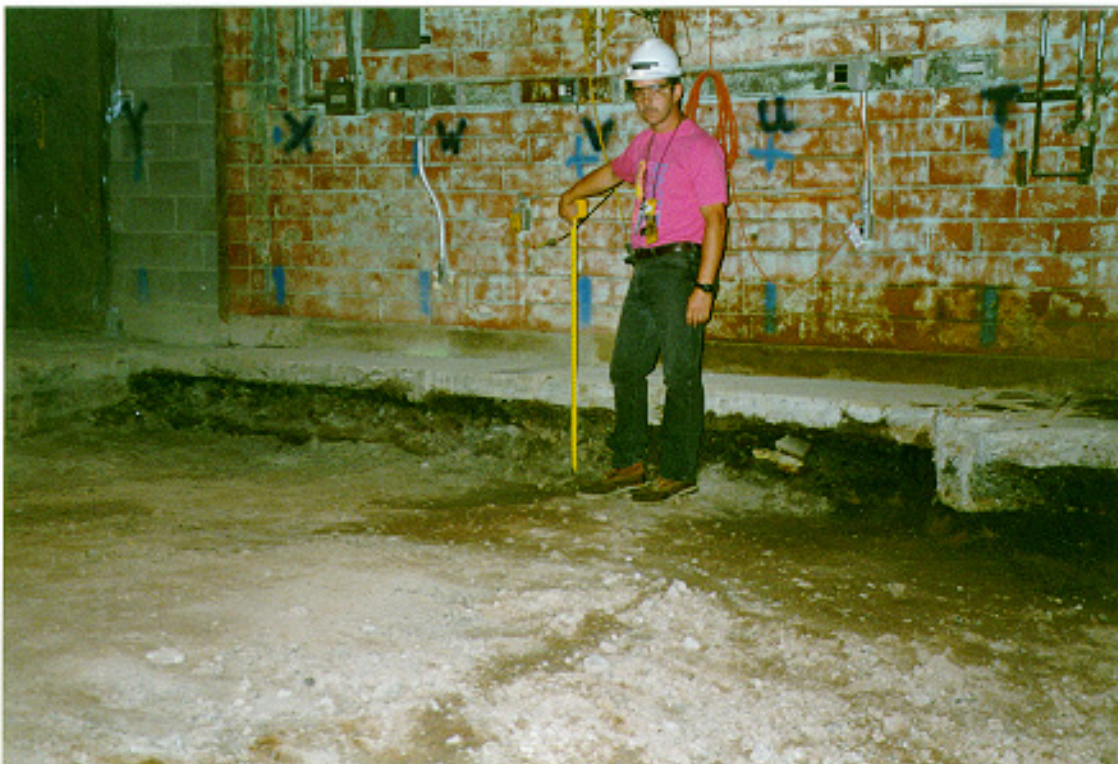
The ash found underneath the slab in Areas 12 and 13 was typically 10 to 12 inches thick but was up to 20 inches thick in places.

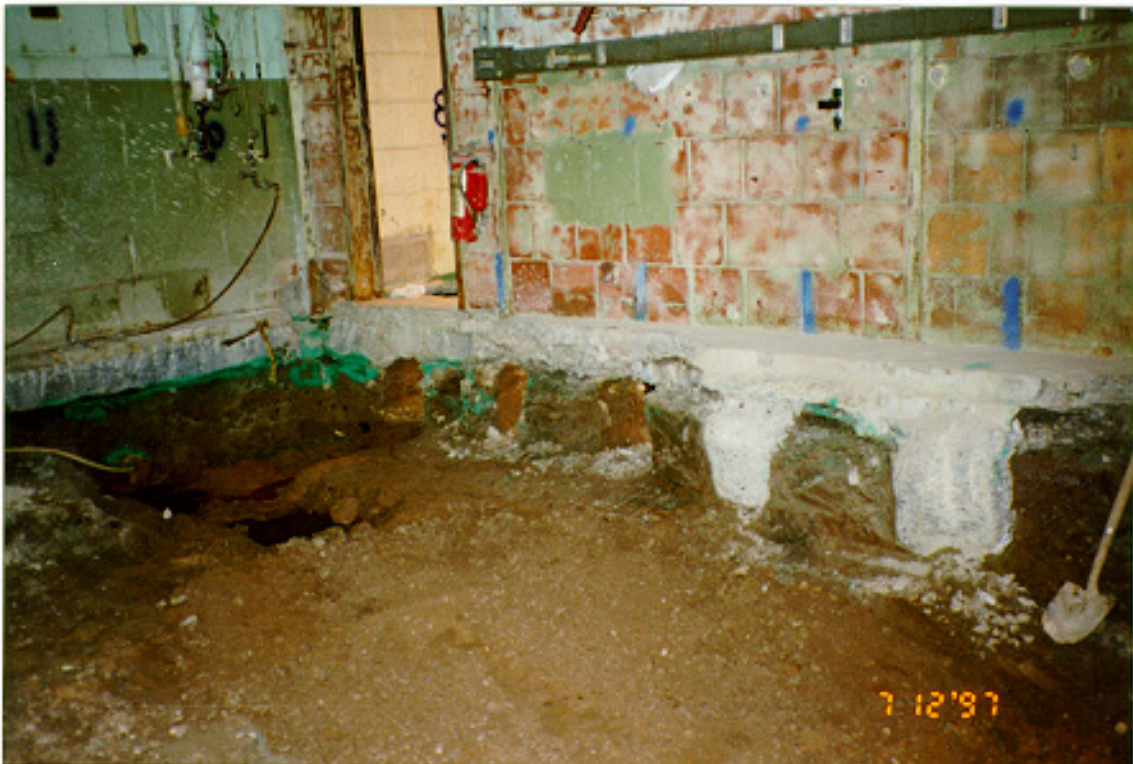
AREAS 12 AND 13

Soil was excavated only to within approximately 1 foot of the wall dividing Areas 12 and 13 in order to maintain the structural integrity of the wall.

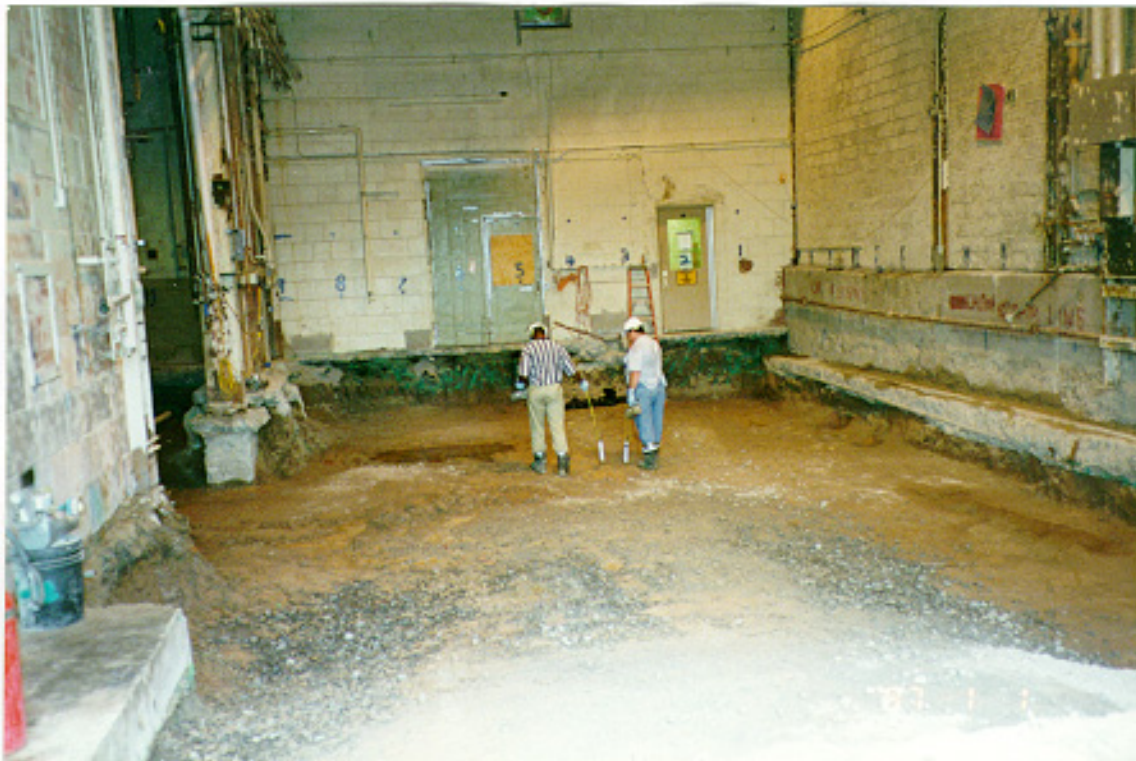
Verification surveys were performed in all excavated areas. This photograph shows a verification survey in Area 12.

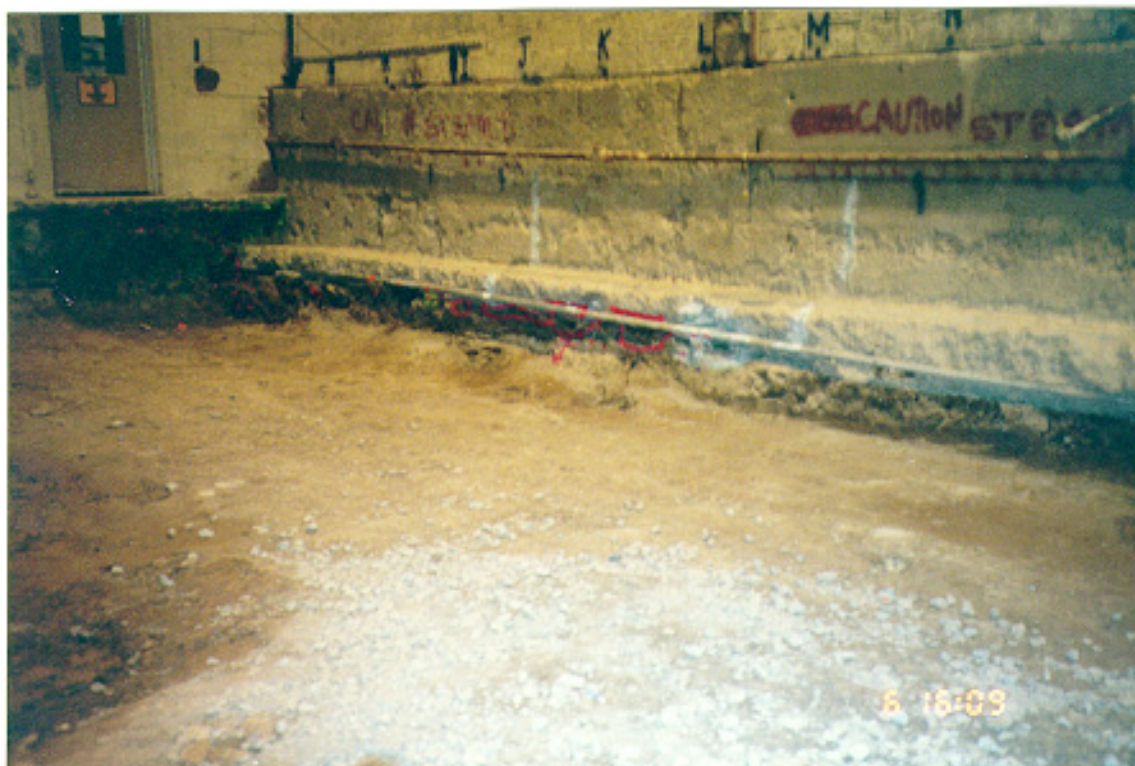
AREAS 12 AND 13

The west wall in Area 12 is supported by a concrete kneewall. Two sections of this wall were designated for supplemental limits.

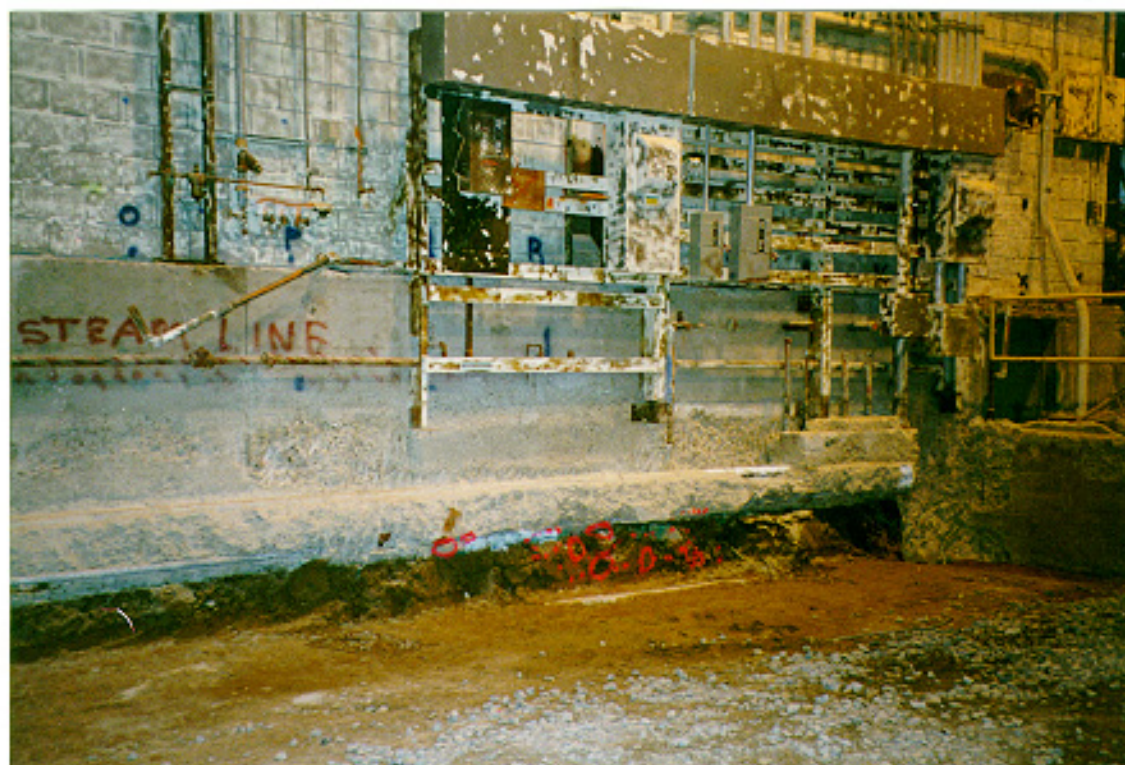
Material clearly identified as yellowcake was found in a sample collected along the knee wall in Area 12.

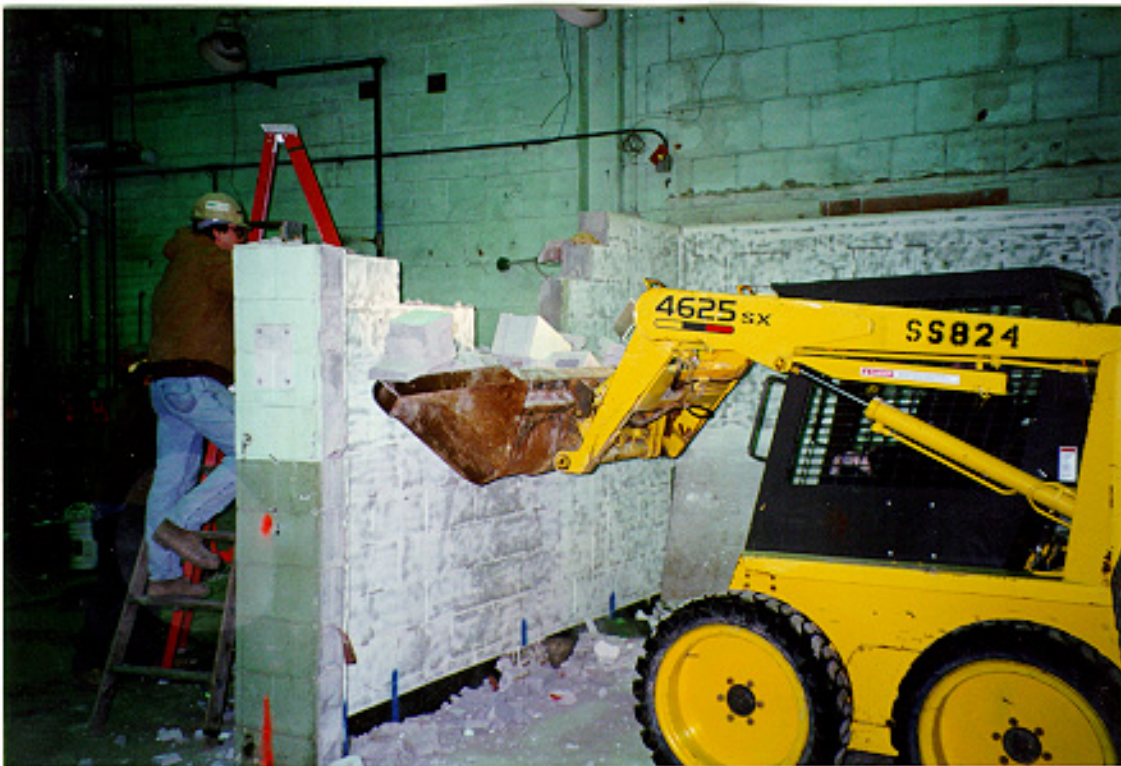
AREA 14 NORTH

The interior walls enclosing Area 14A were demolished to facilitate the removal of underlying contaminated soil.

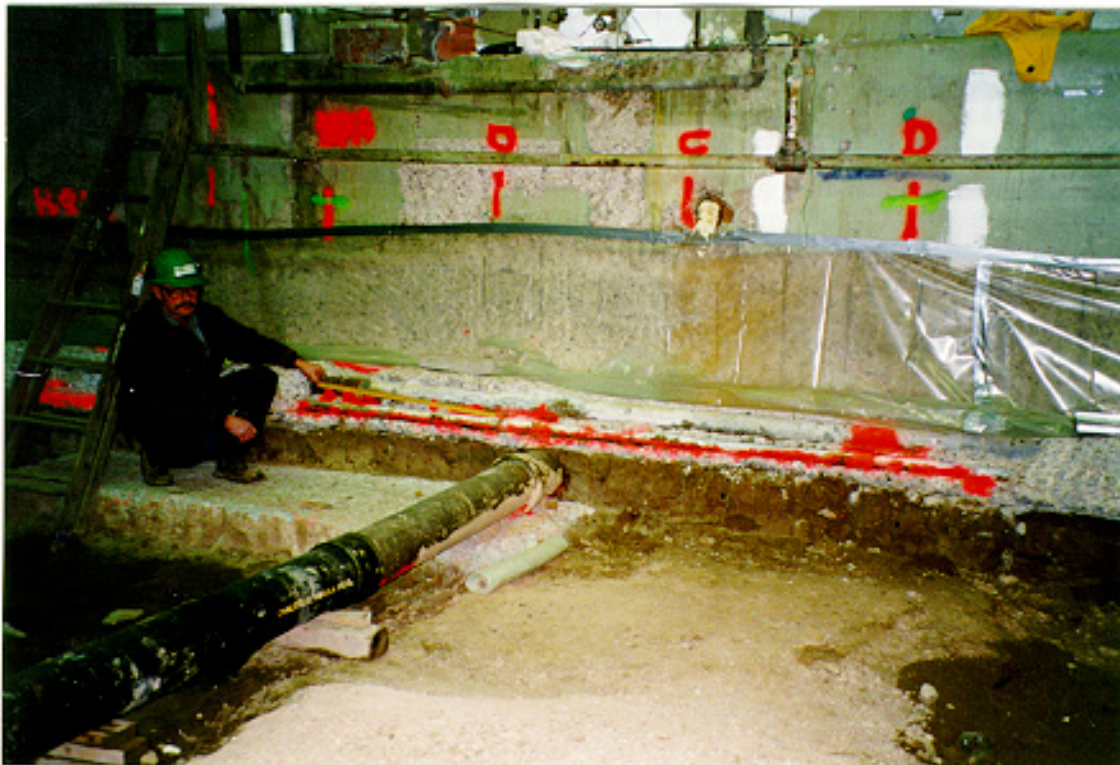
In some areas, soil exceeding the site-specific criterion were left in place because removal of the soil would have jeopardized the structural integrity of the building.

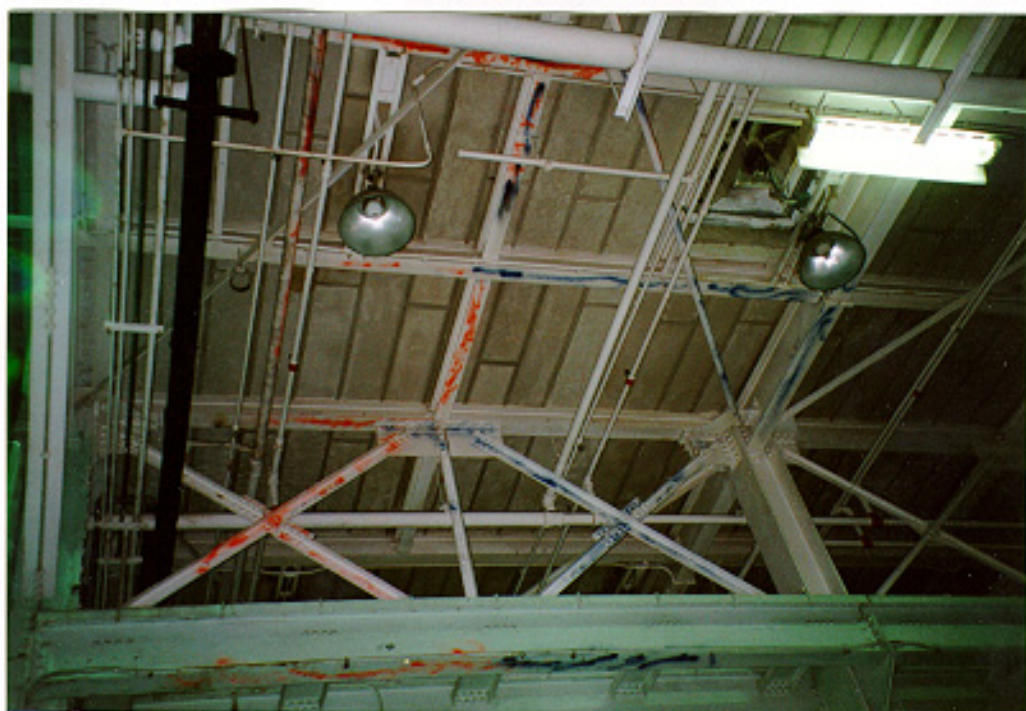
AREA 14 NORTH

The overhead structural steel members were decontaminated below criteria. The creteplank ceiling above the steel members was found to be below criteria.

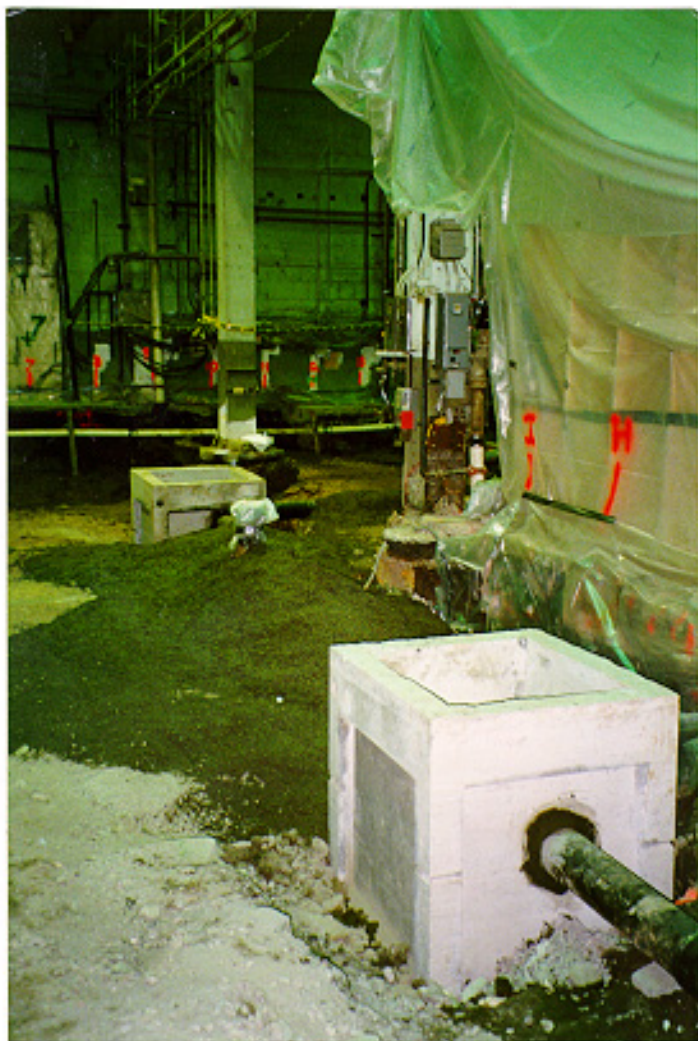
AREA 14 SOUTH

Two sumps located in Area 14 Southwest had surface contamination above the site-specific criterion. Both sumps were removed and replaced.

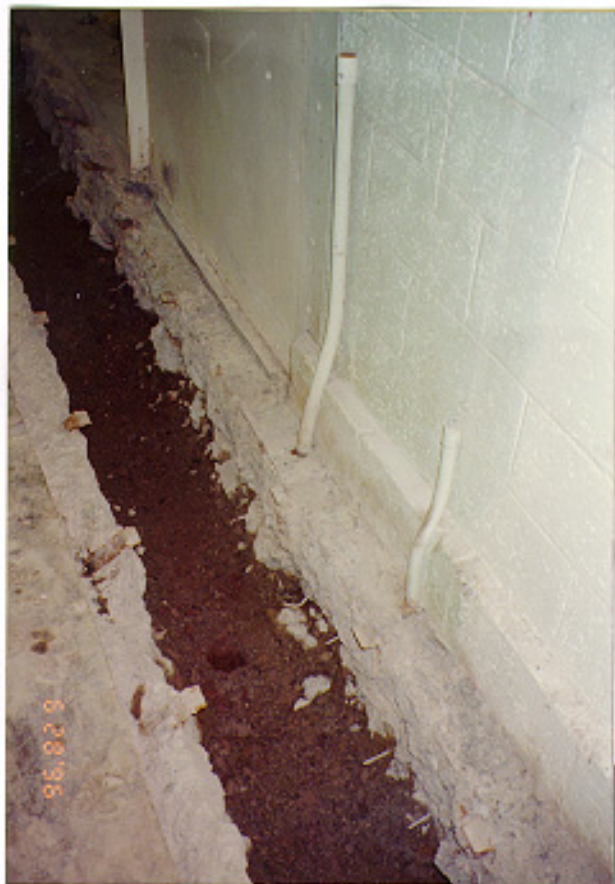
AREA 20A-WEST

The entire length of a concrete trench running through Area 20A-West was contaminated. Remediation consisted mainly of removing the concrete material.

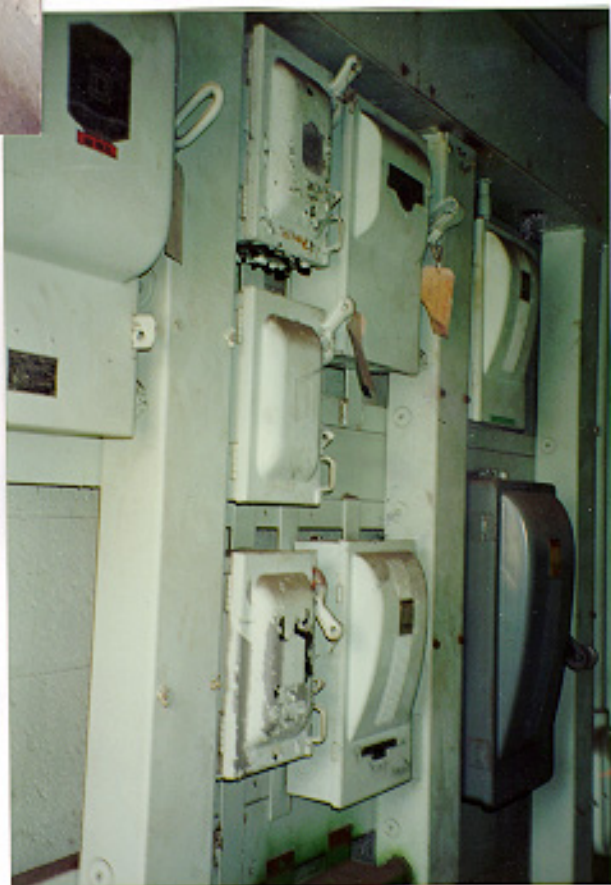
Three electrical panels on the west wall of Area 20C were found to be contaminated and were removed and disposed of. These panels were probably contaminated elsewhere and moved into this area.

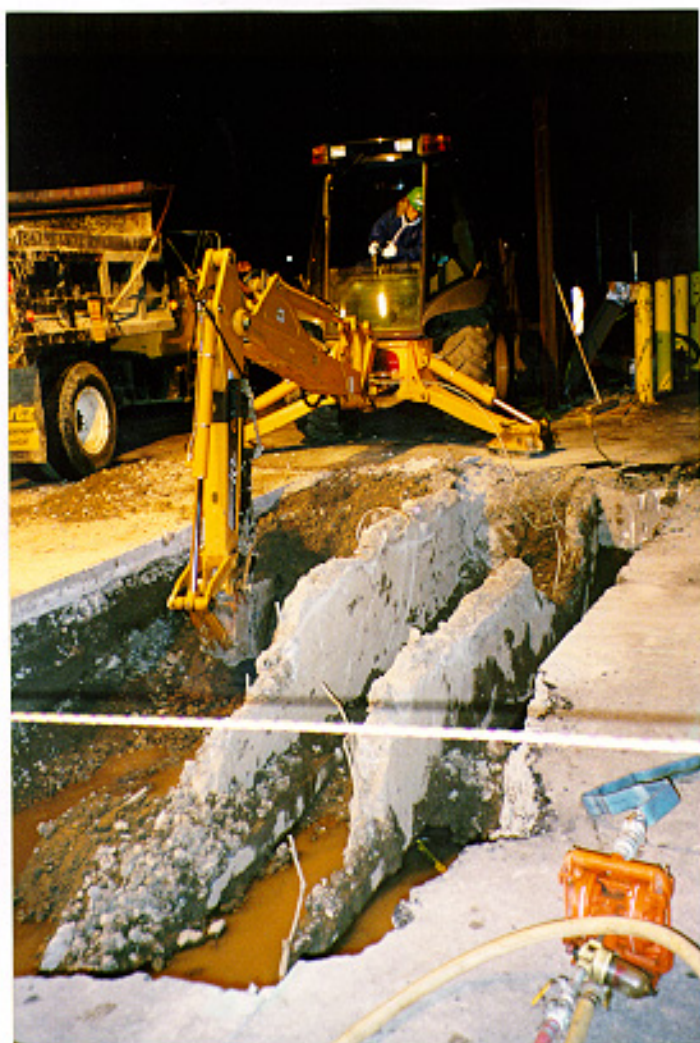
AREA 21

A two-stage settling tank from MED operations was located beneath a relatively new concrete foundation in Area 21. Surveys indicated contamination on most of the bottom and side surfaces of the tank. The tank was broken up and removed by backhoe.
